**REPORT TO THE  
NEW YORK STATE CONSUMER PROTECTION BOARD  
ON THE COSTS OF THE 1991  
REFUELING OUTAGE OF  
INDIAN POINT UNIT 2**

**DECEMBER 1991**

**SCHLISSEL ENGINEERING ASSOCIATES  
45 HORACE ROAD  
BELMONT, MASSACHUSETTS 02178**

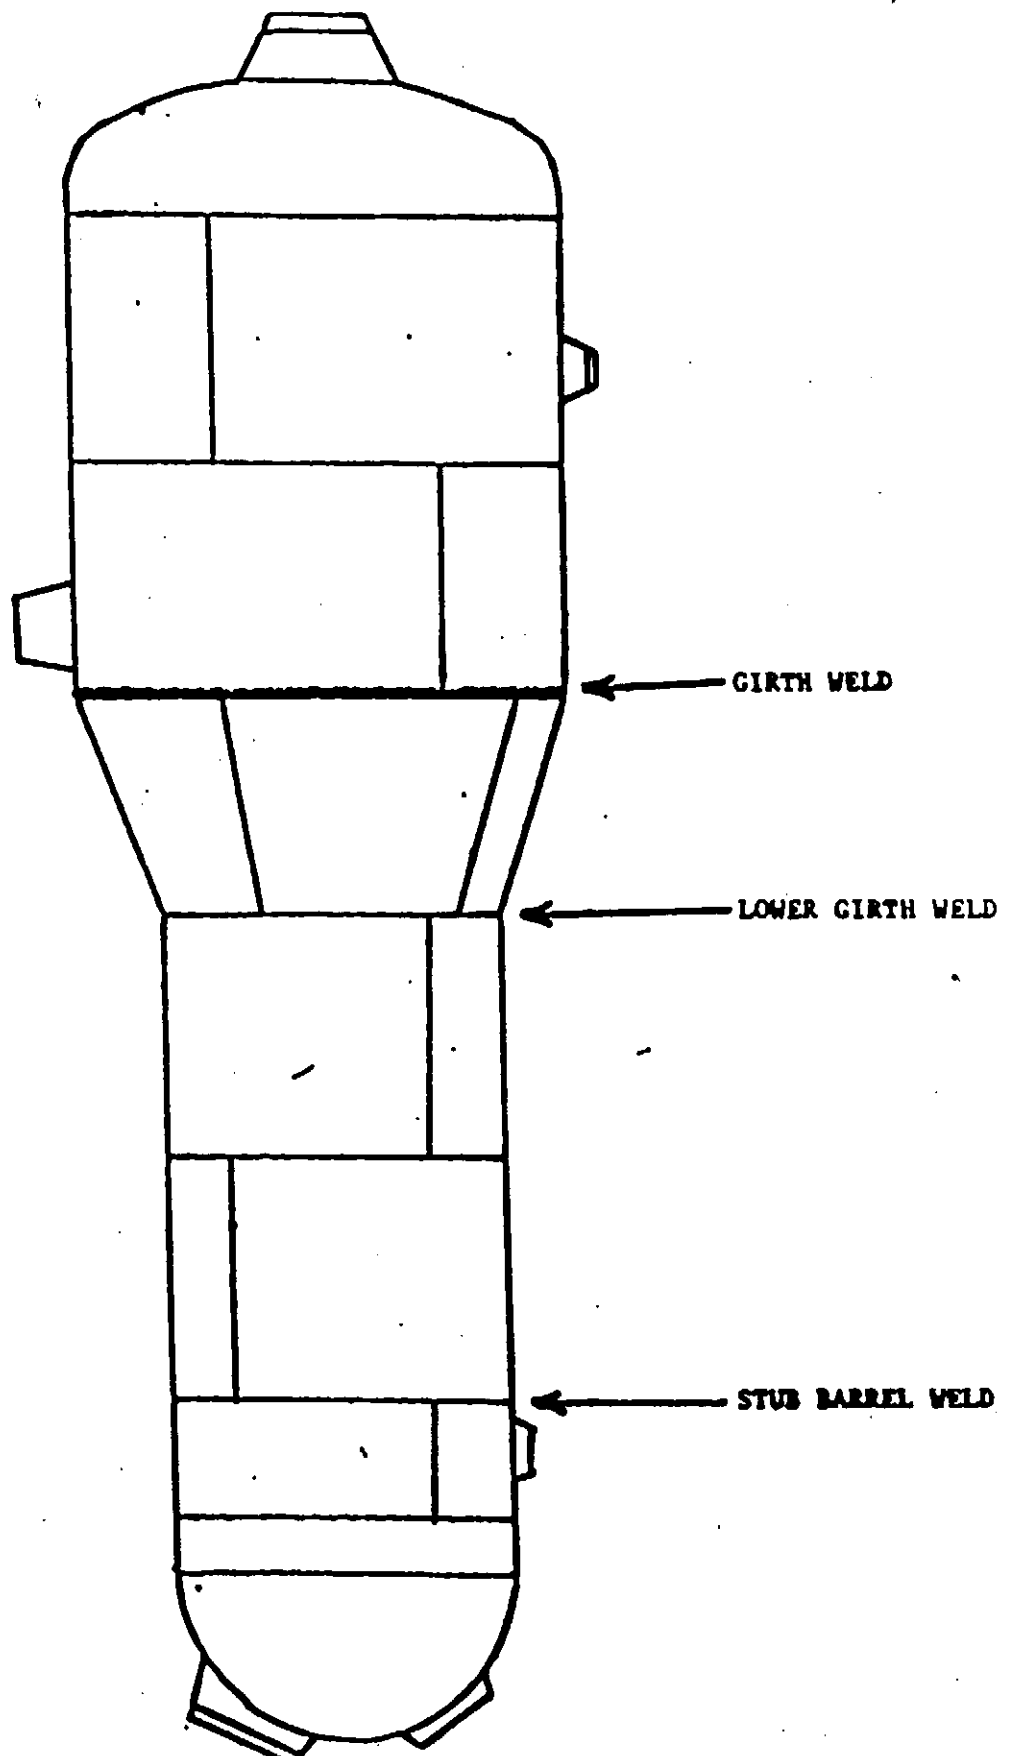
# STEAM GENERATOR SHELL WELDS

Attachment A to this Report is a drawing of one of Indian Point 2's steam generators. The work performed during the 1991 Refueling Outage was undertaken to eliminate the potential for continued cracking in the area identified in this drawing as the girth weld.

Consequently, the repair program implemented by Con Ed in 1990 and 1991 involved several measures to reduce the levels of dissolved oxygen and copper in the secondary system water. In addition, during the 1991 Refueling Outage Con Ed milled out a six-inch wide by 3/4-inch deep groove at the girth weld around the complete circumference of each steam generator. This groove was filled to the original surface with a low sulfur weld material. The contour of this weld was designed to minimize the residual stresses left in the steam generator shell by the welding process. A post-weld heat treatment was also applied to reduce the residual stresses. Finally, the rewelded area was given a smooth surface finish to mitigate pitting.

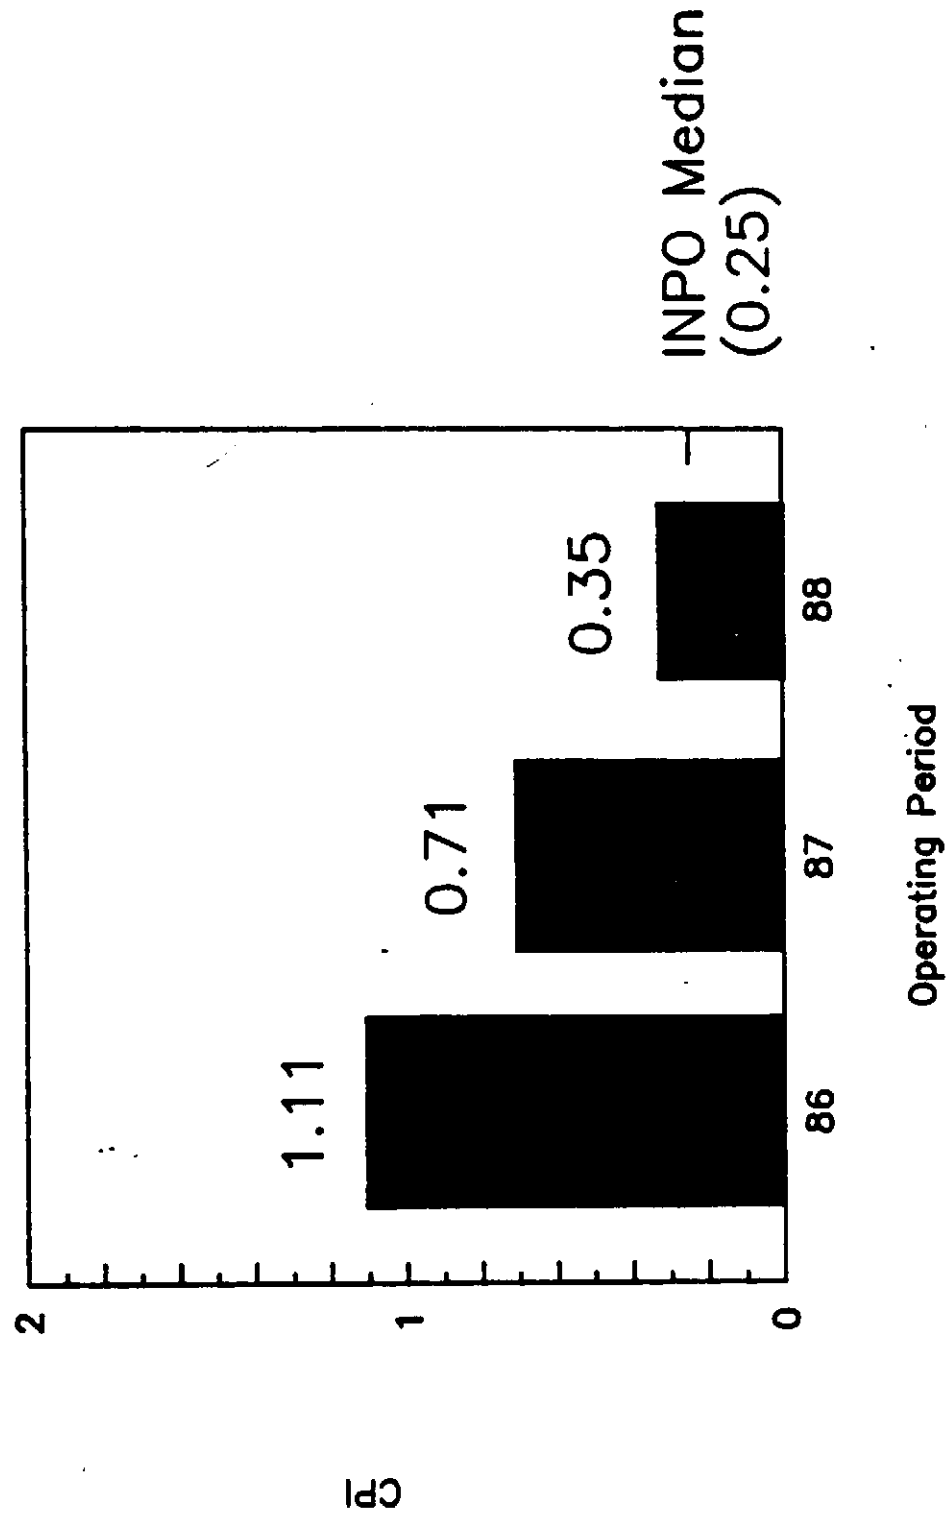
INPO Chemistry Performance Index (CPI)

- \* Consists of five secondary-side water quality parameters
  - \* Condensate System - Dissolved Oxygen (10 ppb)
  - \* Steam Generator Blowdown
    - Chloride (20 ppb)
    - Sulfate (20 ppb)
    - Sodium (20 ppb)
    - Cation Conductivity (0.8 uS/cm)
- \* Used as a report card to track station performance over time and relative to the industry
- \* Implemented by INPO effective January 1988

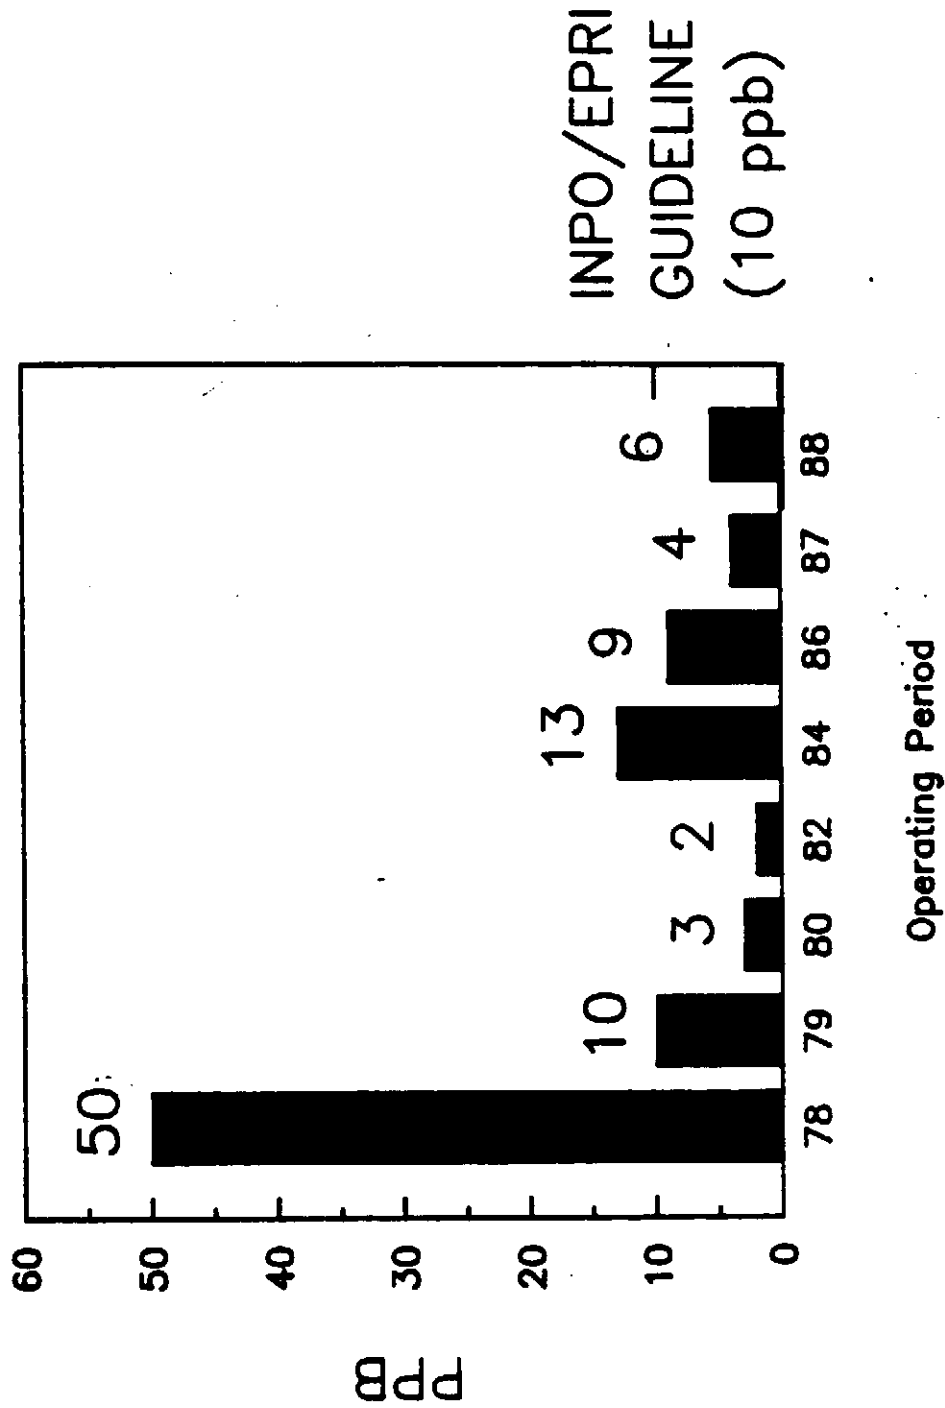
## Condensate Dissolved Oxygen

that the presence of high levels of dissolved oxygen in the secondary system water was the primary contributor to the formation of the pits. The Company further reported to the NRC in June of 1990 that the presence of copper in the secondary system water also contributed to the formation of the pits which preceded the girth weld cracking.
